UNITED STATES ENVIRONMENTAL PROTECTION AGENCY

SUBJ: EPA Asbestos Removal at 209 Watson Street

## REMOVAL ACTION STATUS REPORT DAVIDSON ASBESTOS

**Property Address:** 209 Watson Street, Davidson, Mecklenburg County, North Carolina

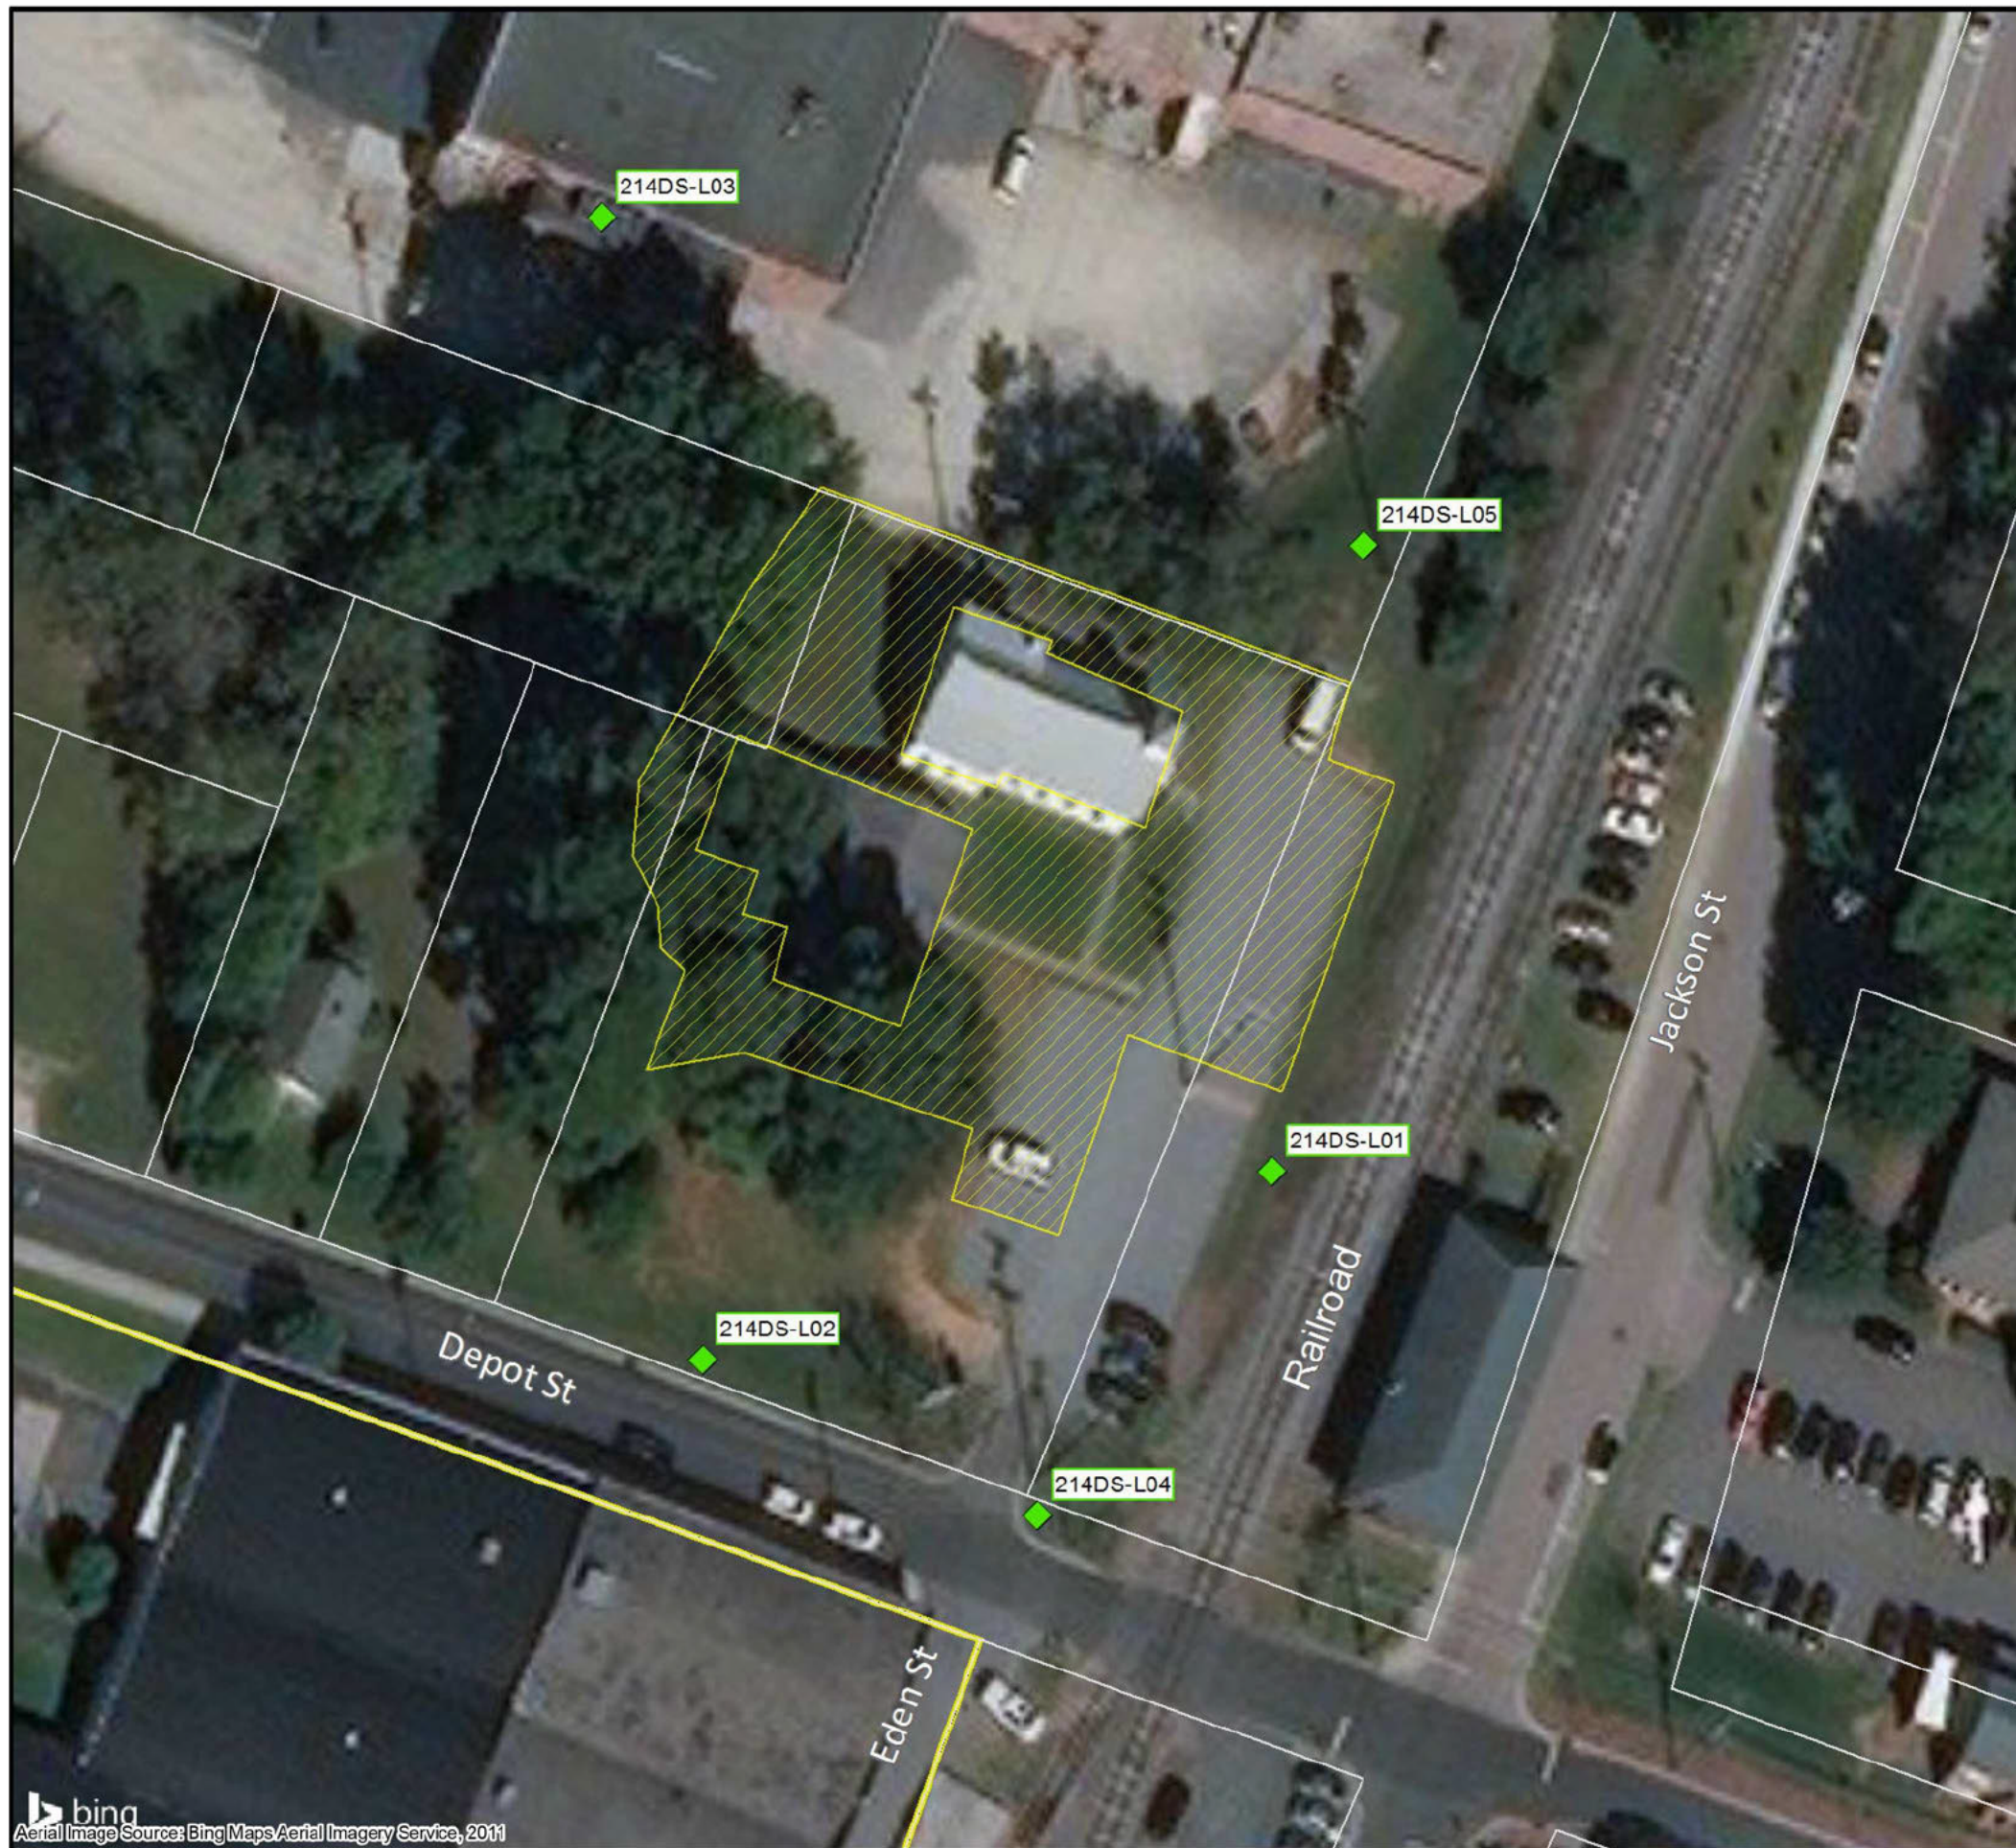
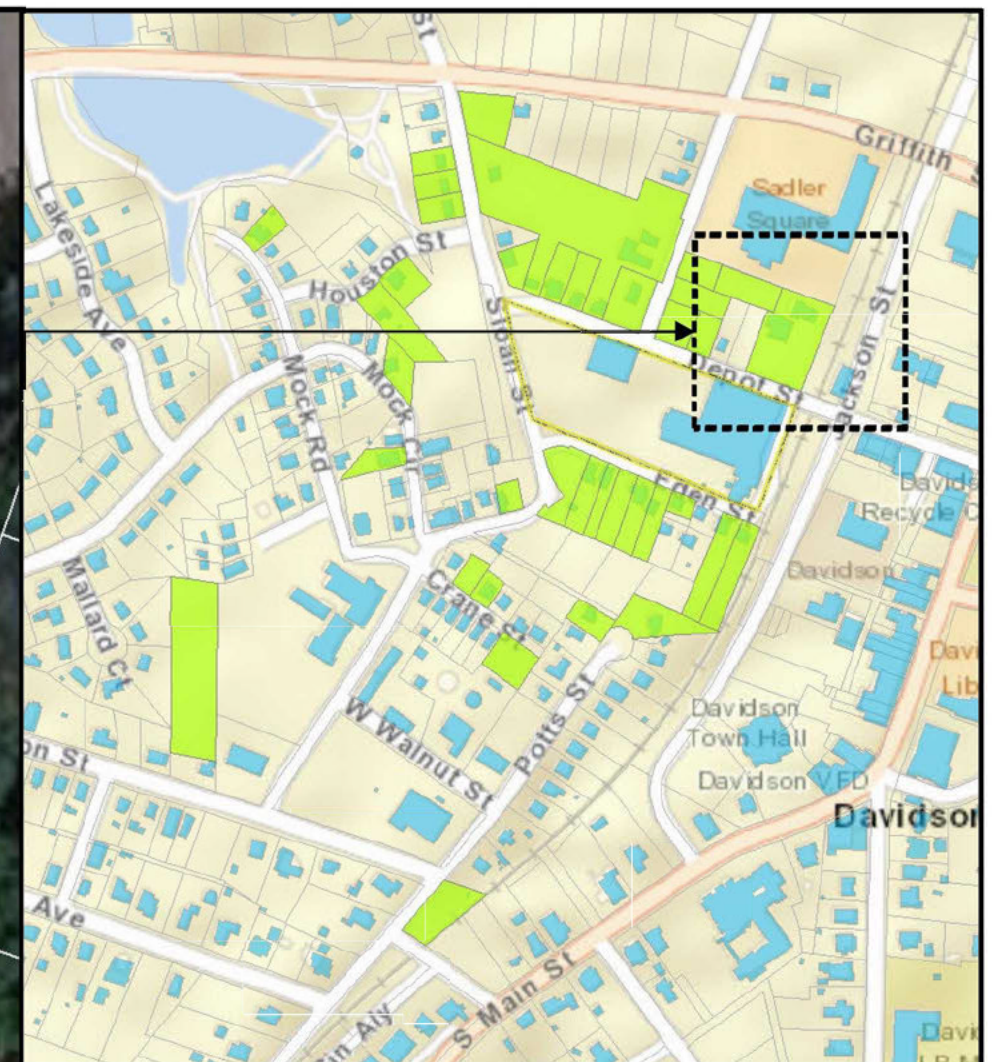
### FIGURE 1

**Description of Removal Action:** The soil was excavated to an approximate maximum depth in the following areas: lawn to 12 inches and under the back stairwell and tree line and residential drip line areas to 3 inches (See Appendix 1). Visual inspections of the areas excavated for asbestos-containing materials (ACM) were conducted by a State of North Carolina-accredited asbestos inspector and air monitor. Additional removal was conducted in those areas where ACM were still visibly present. Once ACM was no longer visibly present, restoration of the excavated areas was allowed to commence.

Removal Areas and  
Air Sampling Locations

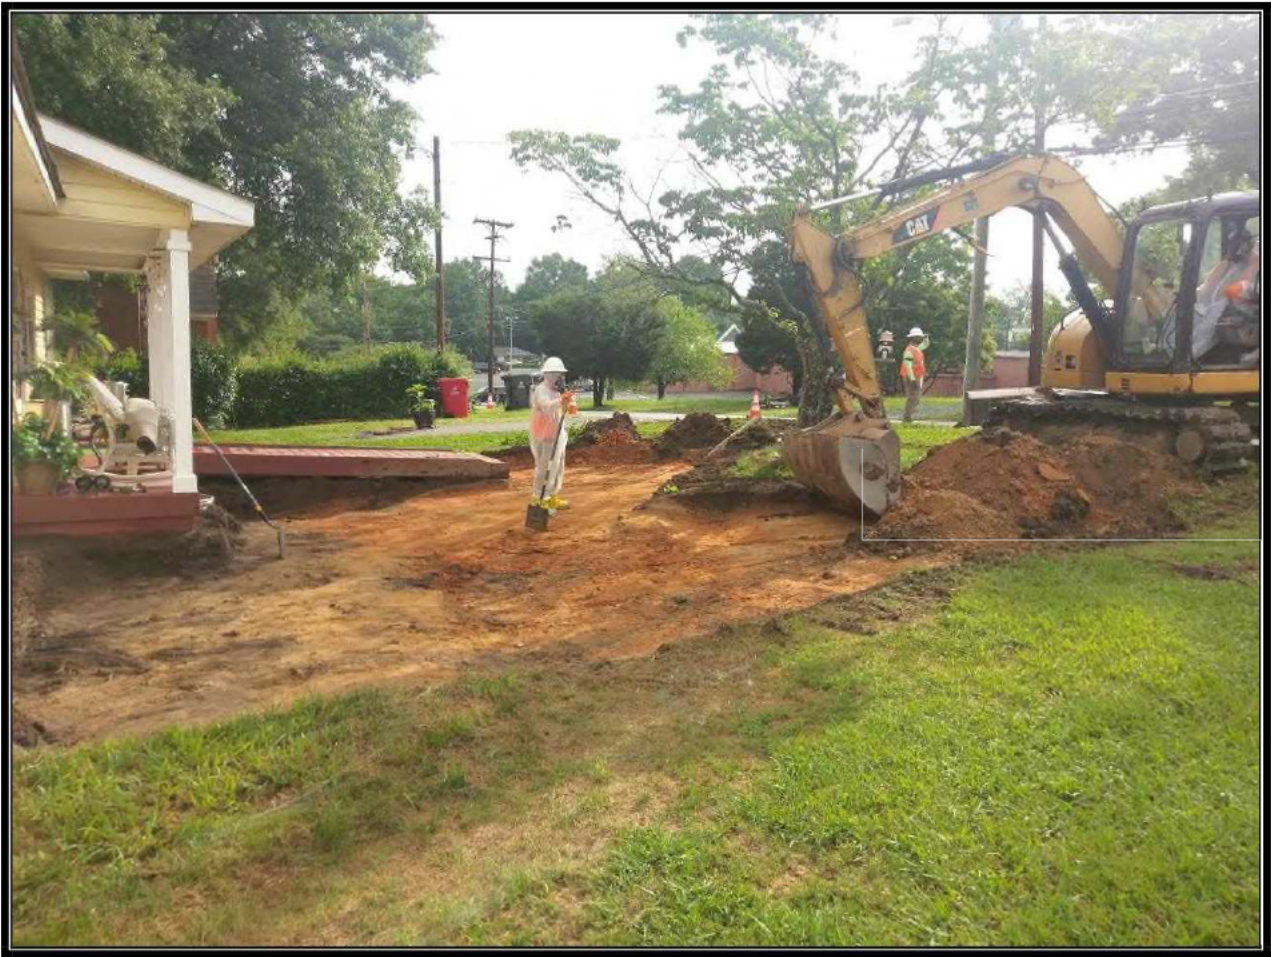
**OFFICIAL PHOTOGRAPH NO. 1  
U.S. ENVIRONMENTAL PROTECTION AGENCY**

**Subject:** The Emergency and Rapid Response Services (ERRS) contractor, Environmental Restoration, LLC (ER), used an excavator and hand tools to remove asbestos-containing materials (ACM) and asbestos-contaminated soil from the lawn located at 209 Watson Street. ER used hoses to wet the asbestos-contaminated soil during removal activities.

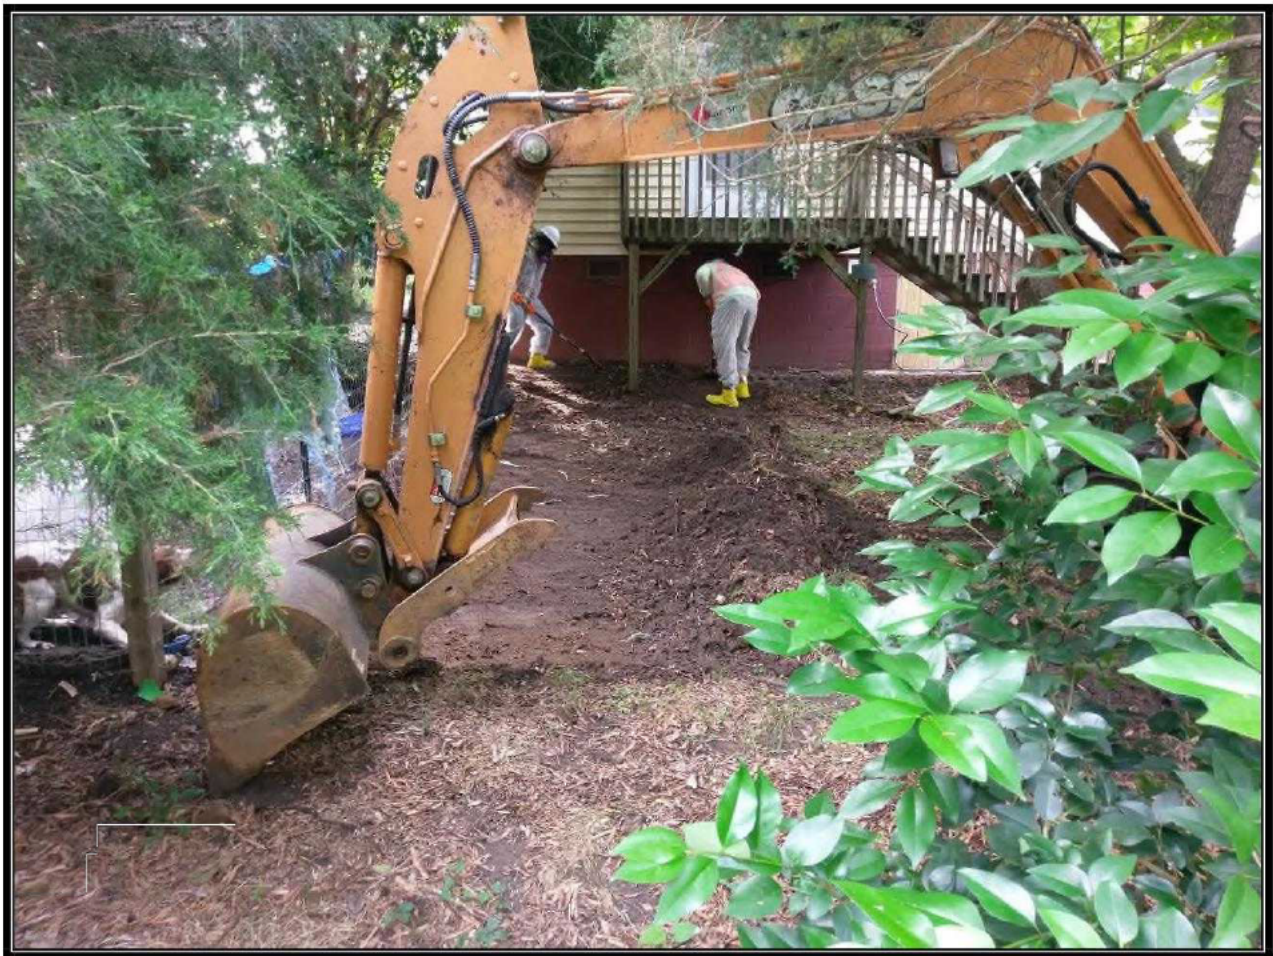
**OFFICIAL PHOTOGRAPH NO. 2**  
**U.S. ENVIRONMENTAL PROTECTION AGENCY**

**Subject:** ER used an excavator and hand tools to remove ACM and asbestos-contaminated soil from under the tree lines and back stairwell located at 209 Watson Street. ER used hoses to wet the asbestos-contaminated soil during removal activities.

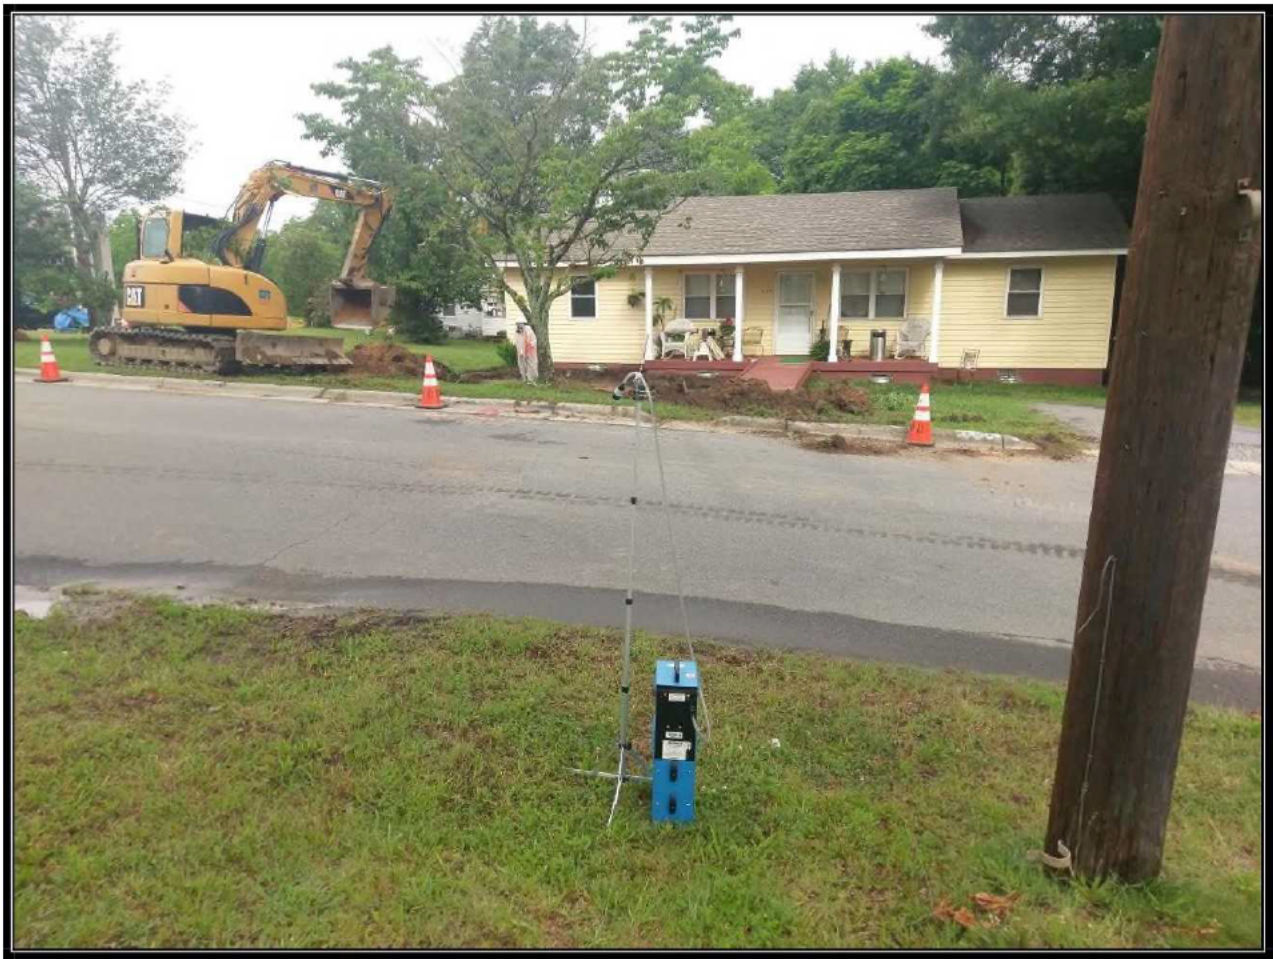
**OFFICIAL PHOTOGRAPH NO. 3**  
**U.S. ENVIRONMENTAL PROTECTION AGENCY**

**Subject:** Perimeter air sampling was conducted by a Tetra Tech START, State of North Carolina-accredited air monitor to evaluate the effectiveness of engineering and safety controls in preventing the off-site migration of asbestos fibers during removal activities.

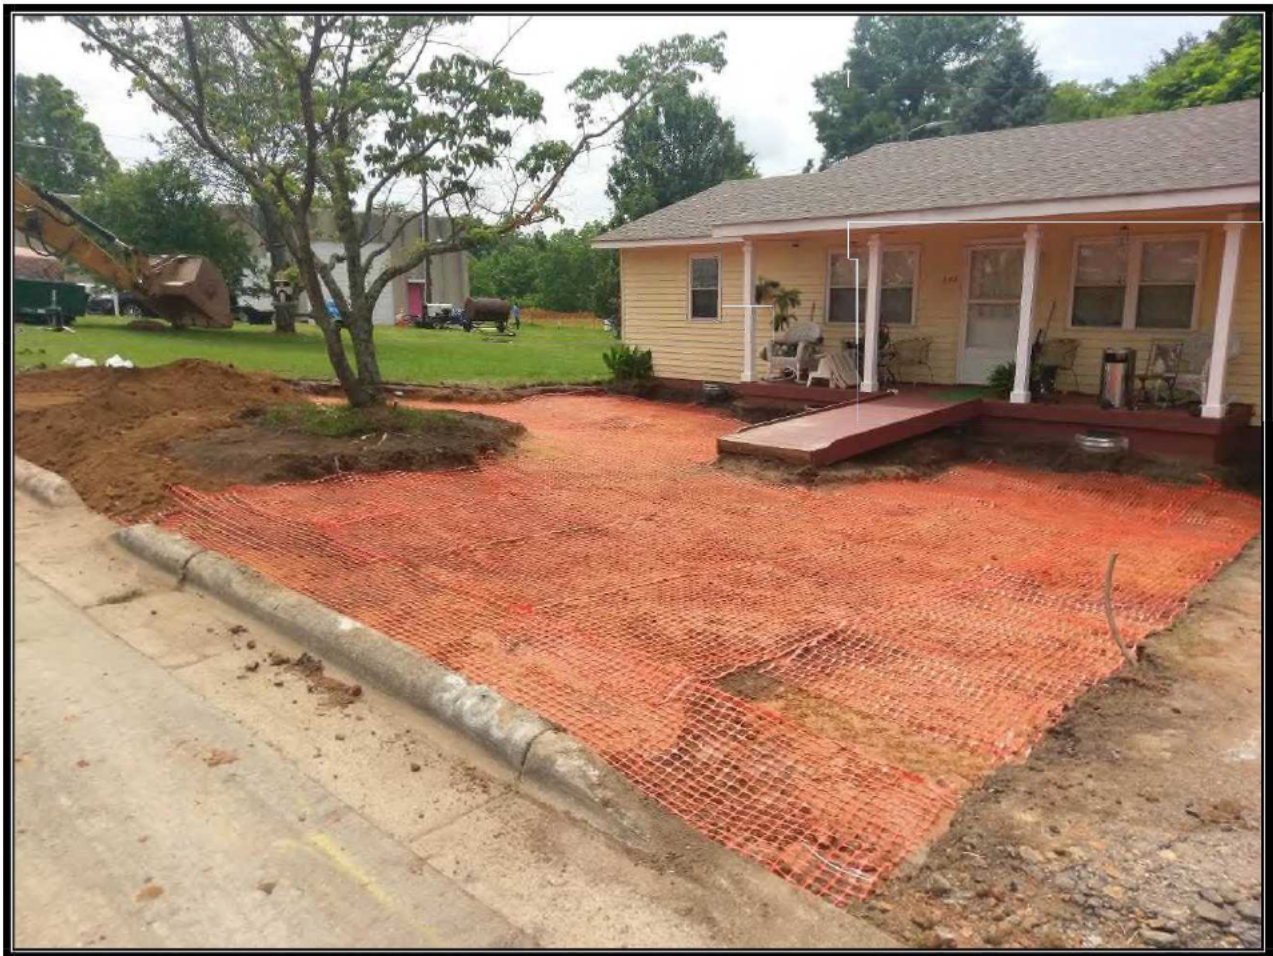
**OFFICIAL PHOTOGRAPH NO. 4**  
**U.S. ENVIRONMENTAL PROTECTION AGENCY**

**Subject:** ER installed snow fencing along the subsurface of the excavated area after the visual inspection conducted by the Tetra Tech START, State of North Carolina-accredited asbestos inspector and air monitor detected no visible ACM in the excavated area.

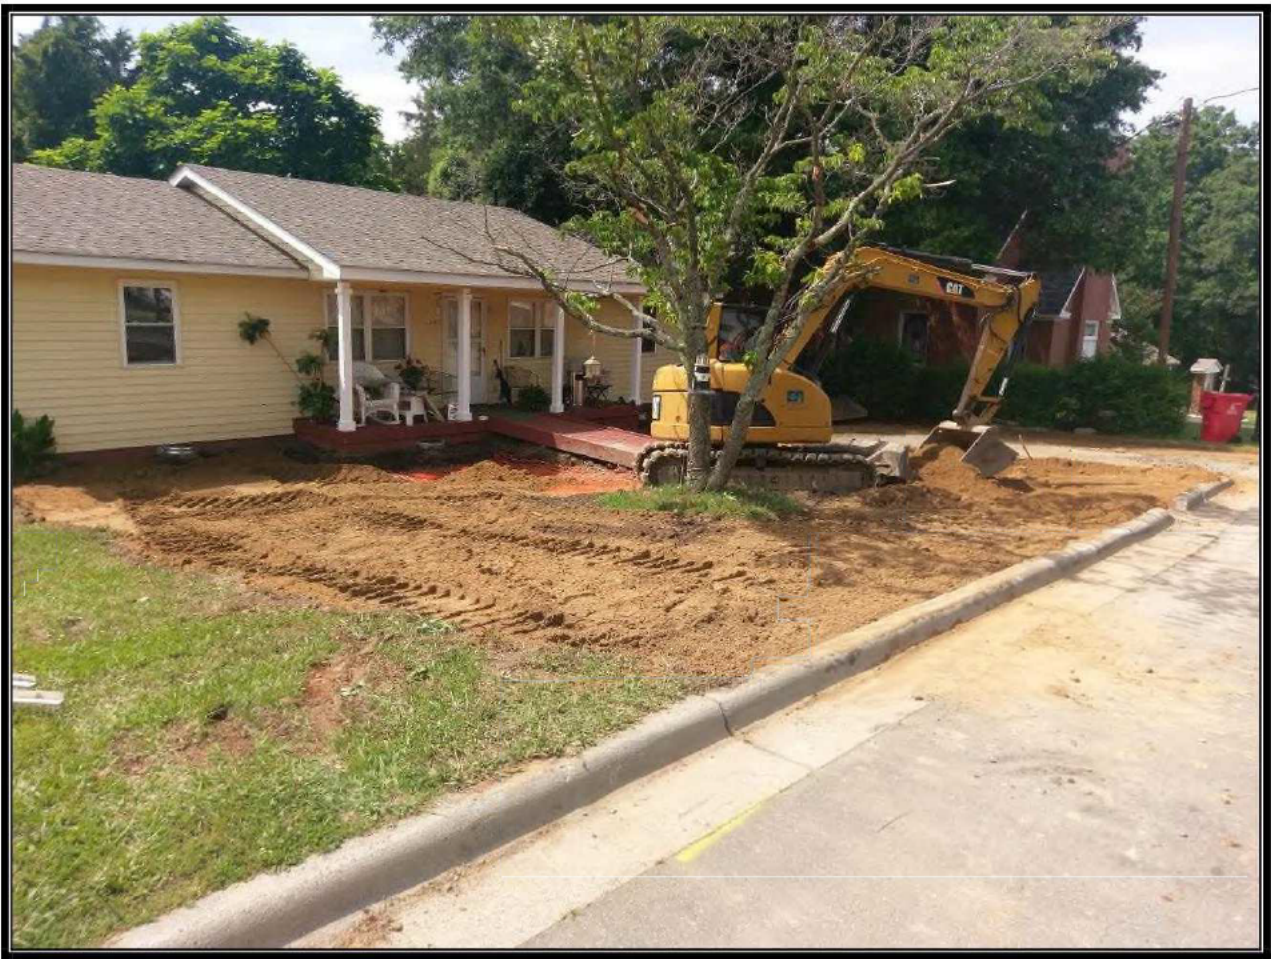
**OFFICIAL PHOTOGRAPH NO. 5**  
**U.S. ENVIRONMENTAL PROTECTION AGENCY**

<b>TDD Number:</b>	TT-01-071	<b>Location:</b>	Davidson Asbestos
<b>Orientation:</b>	Northwest	<b>Date:</b>	May 30, 2017
<b>Photographer:</b>	Paul Prys, Tetra Tech	<b>Witness:</b>	None
<b>Subject:</b>	ER used dump trucks, excavators, and skid steers to install backfill in the excavated areas.

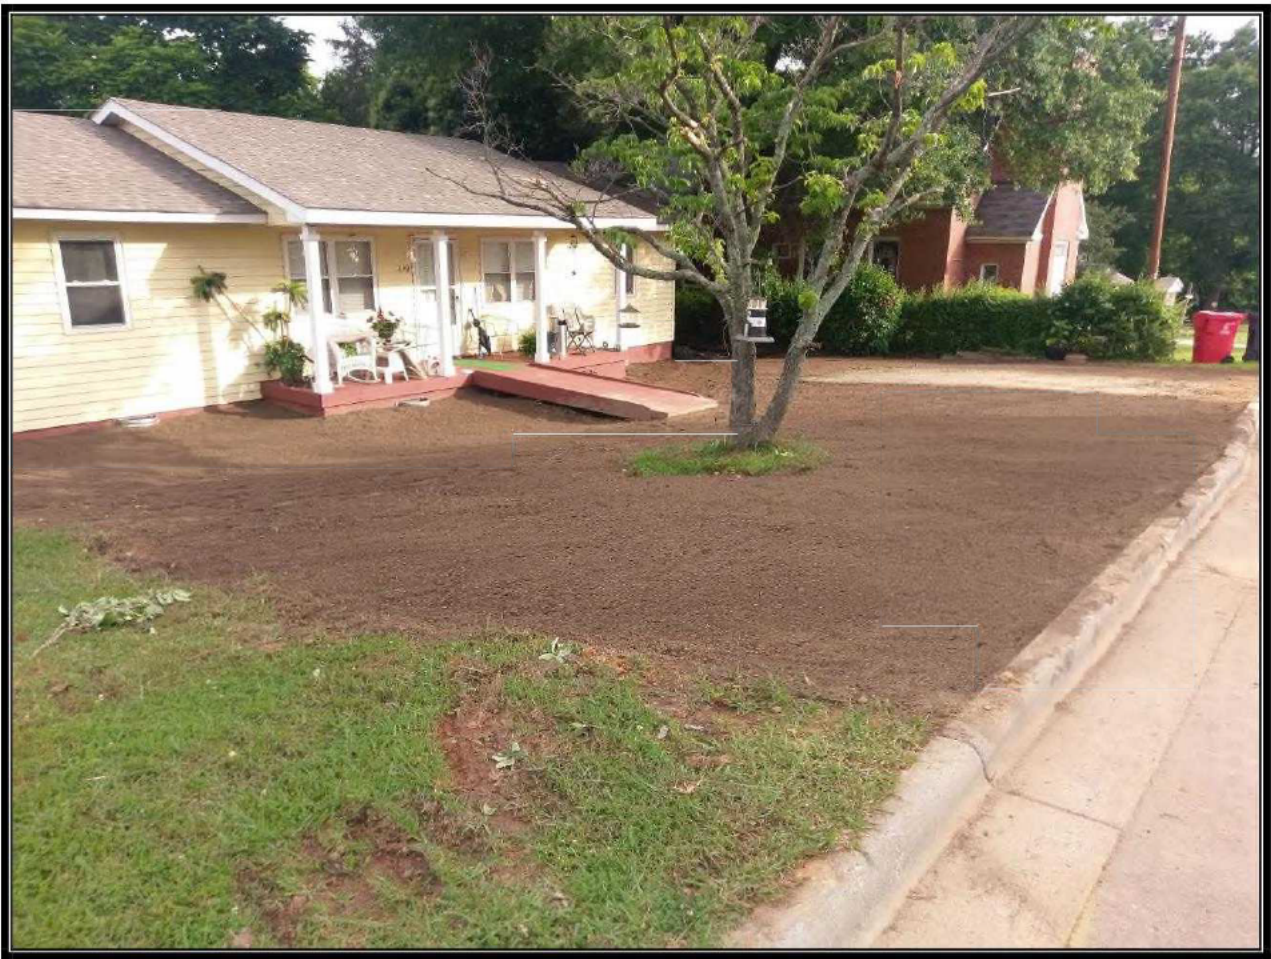
**OFFICIAL PHOTOGRAPH NO. 6**  
**U.S. ENVIRONMENTAL PROTECTION AGENCY**

<b>TDD Number:</b>	TT-01-071	<b>Location:</b>	Davidson Asbestos
<b>Orientation:</b>	Northwest	<b>Date:</b>	May 31, 2017
<b>Photographer:</b>	Paul Prys, Tetra Tech	<b>Witness:</b>	None
<b>Subject:</b>	ER used dump trucks, skid steers, and rakes to install topsoil in the excavated areas.

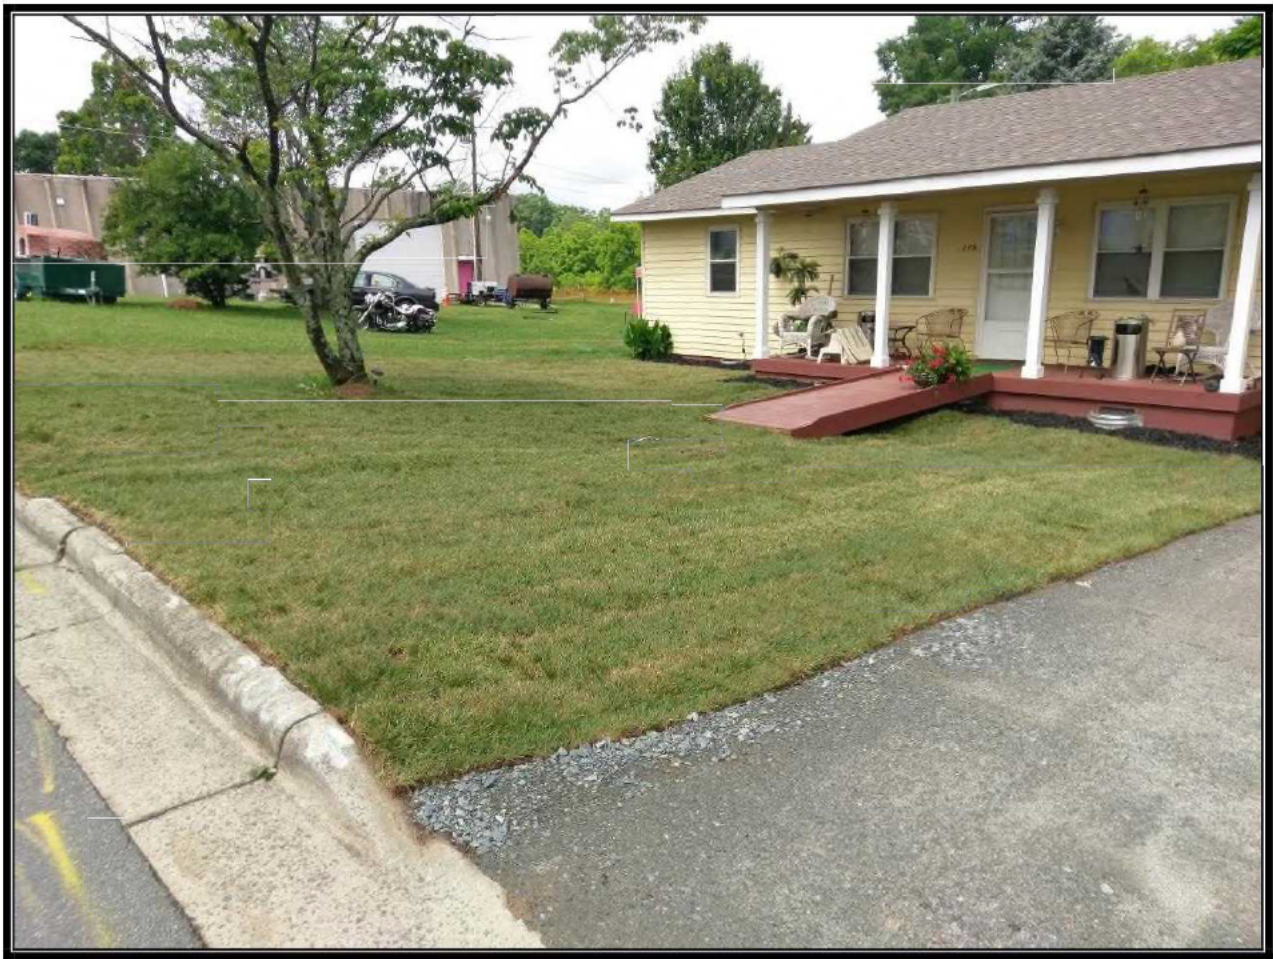
**OFFICIAL PHOTOGRAPH NO. 7**  
**U.S. ENVIRONMENTAL PROTECTION AGENCY**

<b>TDD Number:</b>	TT-01-071	<b>Location:</b>	Davidson Asbestos
<b>Orientation:</b>	Southwest	<b>Date:</b>	June 5, 2017
<b>Photographer:</b>	Paul Prys, Tetra Tech	<b>Witness:</b>	None
<b>Subject:</b>	ER installed sod in the excavated areas after backfill and topsoil were in place.

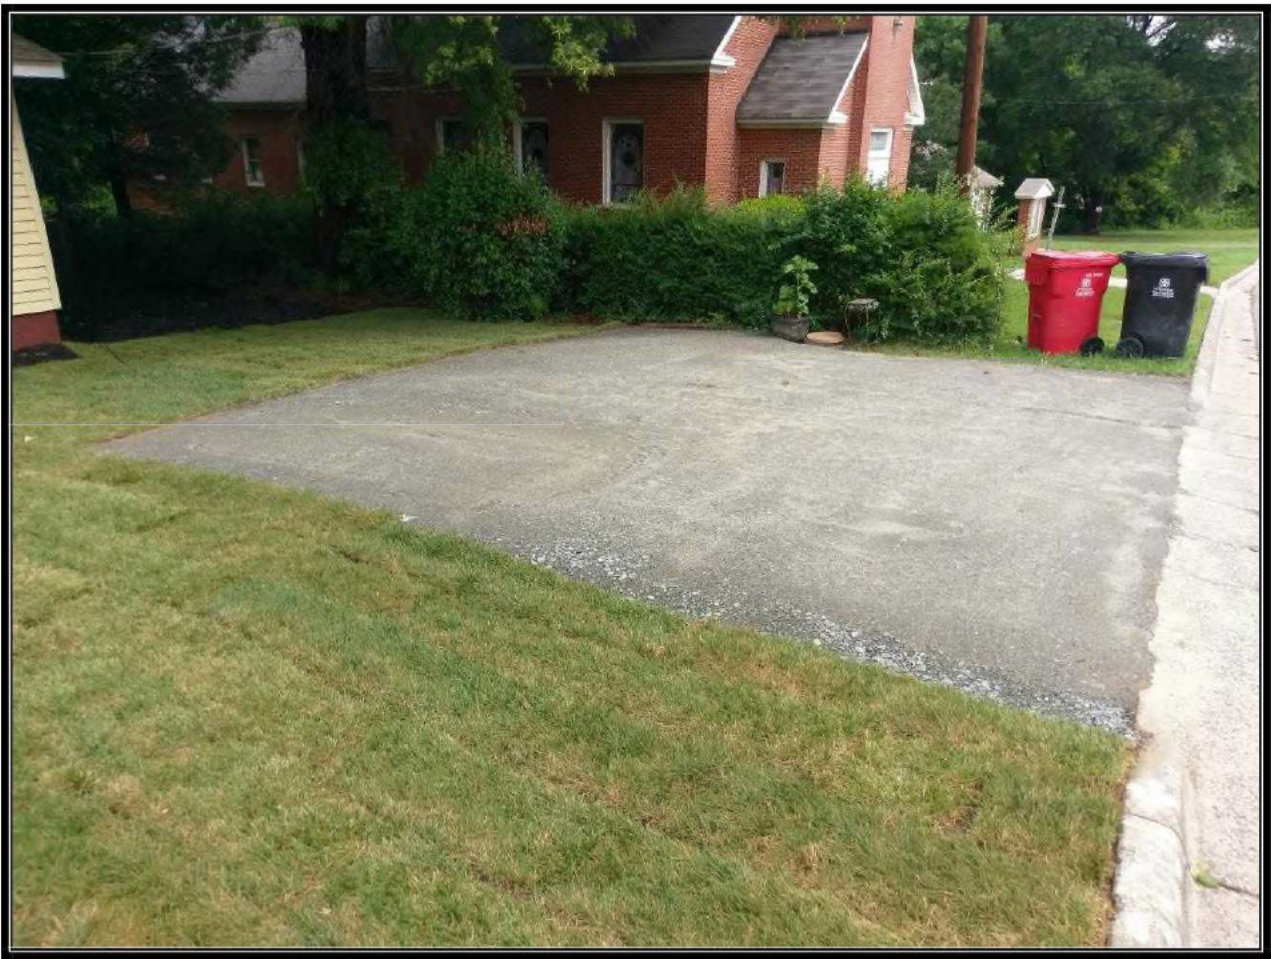
**OFFICIAL PHOTOGRAPH NO. 8**  
**U.S. ENVIRONMENTAL PROTECTION AGENCY**

<b>TDD Number:</b>	TT-01-071	<b>Location:</b>	Davidson Asbestos
<b>Orientation:</b>	Northwest	<b>Date:</b>	June 5, 2017
<b>Photographer:</b>	Paul Prys, Tetra Tech	<b>Witness:</b>	None
<b>Subject:</b>	ER installed crushed rock in the driveway area after backfill was installed.

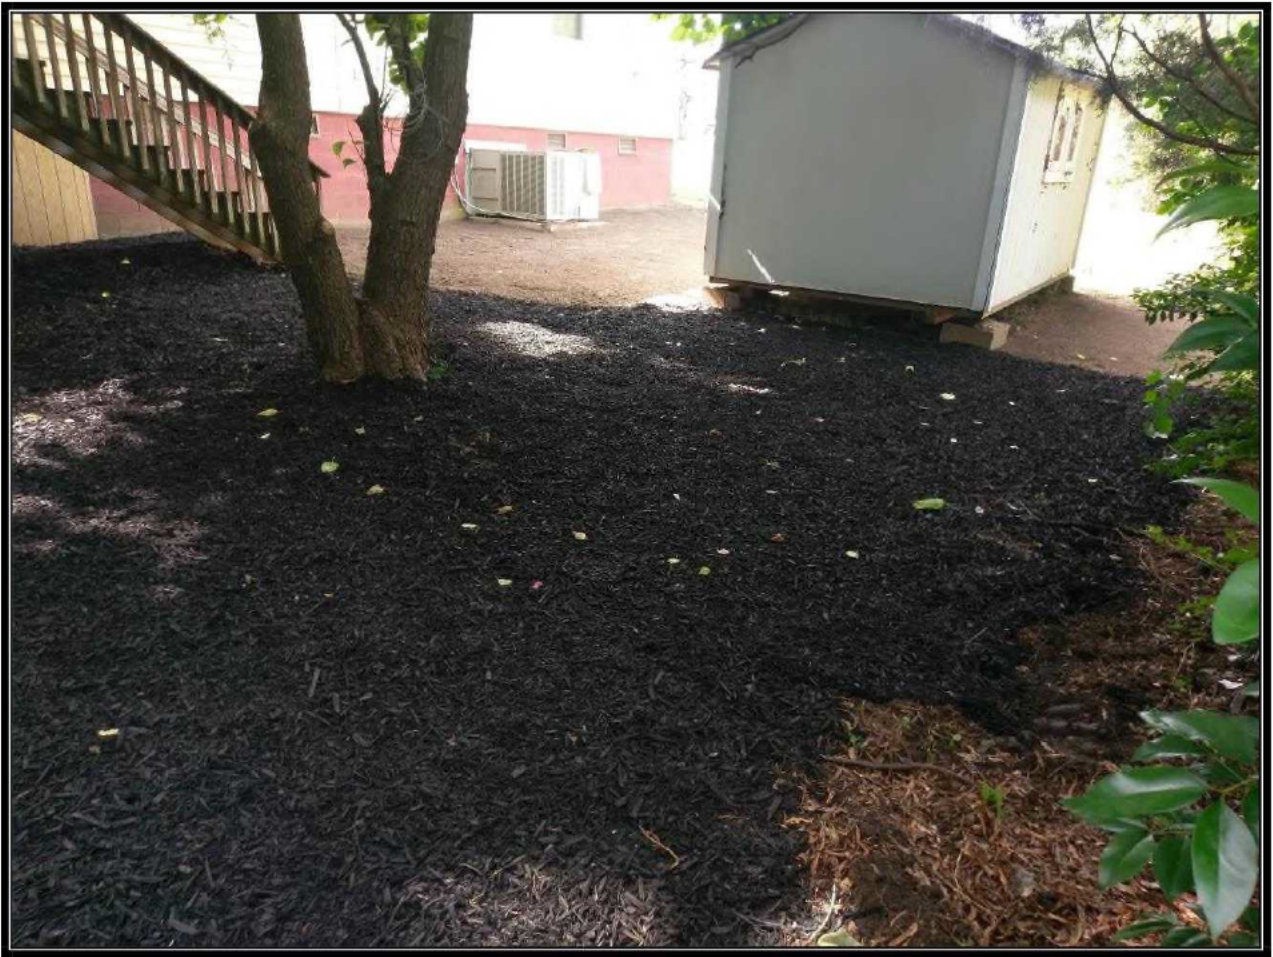
**OFFICIAL PHOTOGRAPH NO. 9**  
**U.S. ENVIRONMENTAL PROTECTION AGENCY**

**Subject:** ER installed mulch under the tree line areas and the stairwell that had been surface scraped after topsoil was installed.
